FOR <i>K. Faw</i> <i>(for R.P.B.)</i> R. P. Bass	SUBJECT CLASSIFICATION <i>Bushings - Capacitors</i>	NO. 50TP170-1
		DATE 7/19/51

The Operation of 5 Kv Glass and Porcelain  
Bushings in Salt-Fog Atmosphere. Report II

INFORMATION PREPARED FOR High Voltage Bushing Division

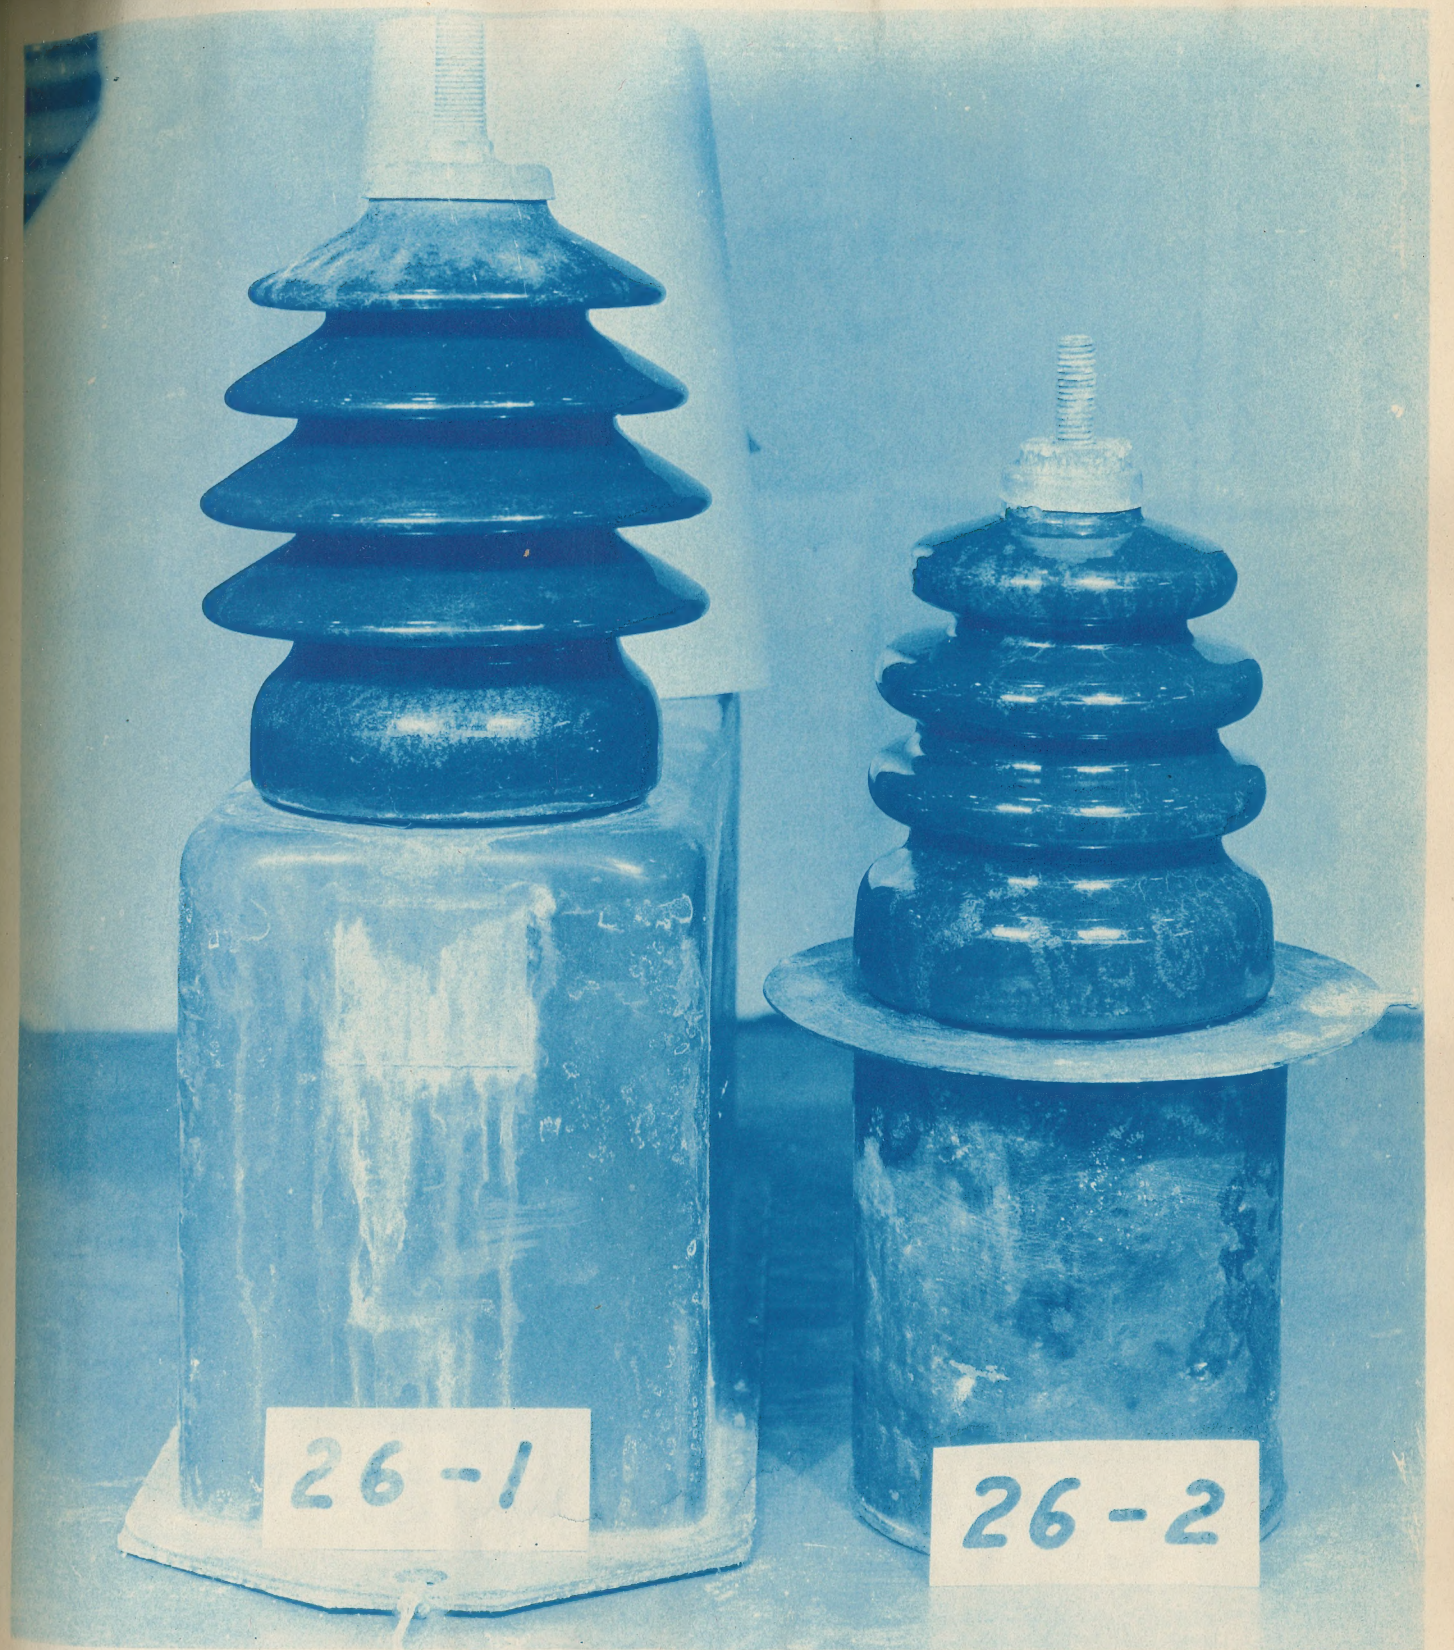
3017367

(A) OVERSIZE 5KV PORCELAIN BUSHING (B) STANDARD 5KV PORCELAIN BUSHING

FIGURE I RESULTS OF A 550 HOUR SALT RUN ON 5KV PORCELAIN BUSHINGS

1. The oversize 5 kv G.E. porcelain bushing had a total of 68% fewer leakage current surges above 10 ma. and also less surface deterioration than the standard 5 kv G.E. porcelain bushing. Figures I, II, and X.

Test Bushings	Results
(a) Oversize 5 kv porcelain K-5239328 AB G-8	Frequent arcing, heavy tracking top petticoat. (See Fig. I)
(b) 5 Kv G.E. porcelain	Frequent arcing, scattered heavy tracking. (See Fig. I)
(c) 5 Kv G.E. amber glass	Frequent arcing, scattered heavy tracking.
(d) 5 Kv G.E. glass, coated with F 1113	Very frequent arcing, coating badly burned.
(e) 5 Kv G.E. glass, coated with R 402.	Very frequent arcing, coating badly burned.

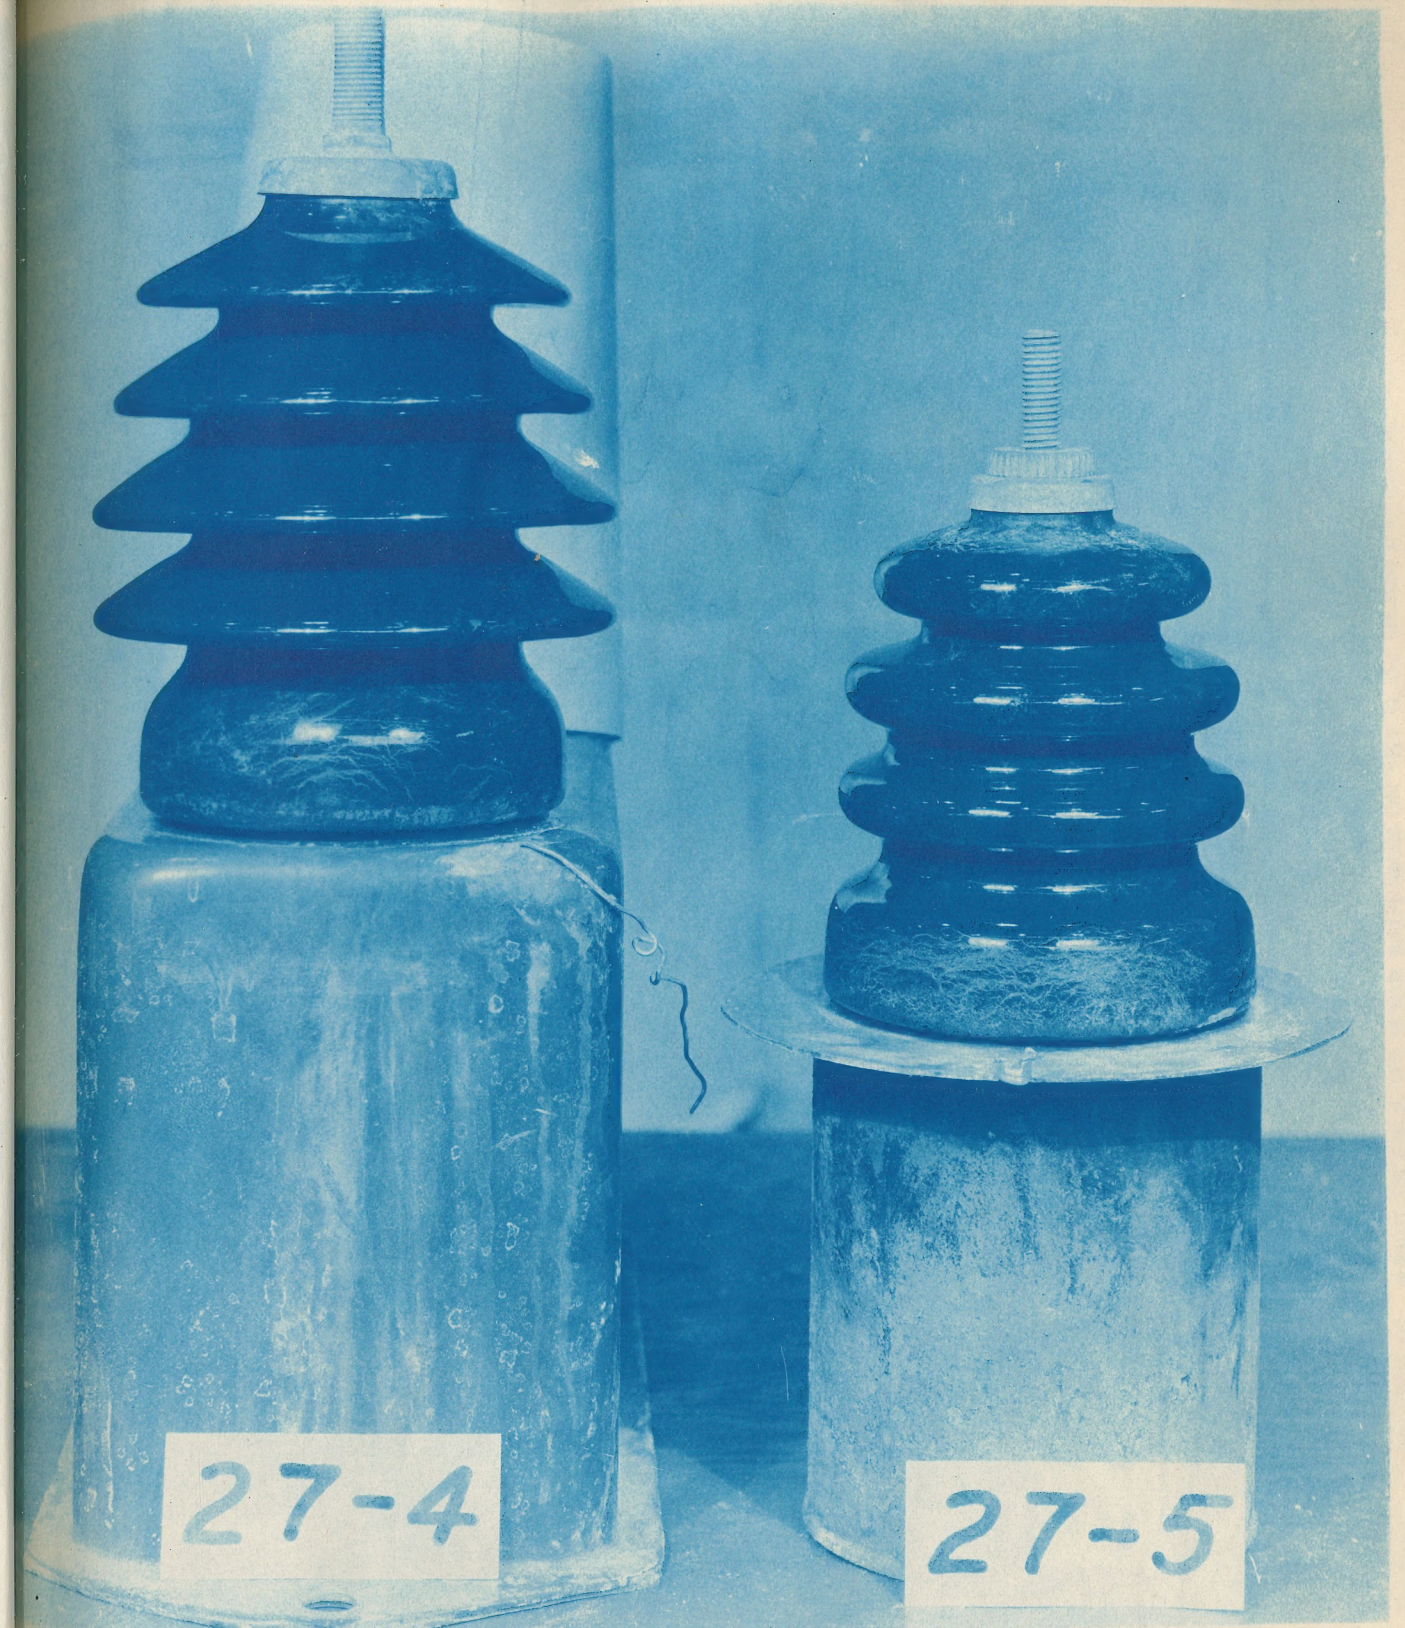
3017369  
Transformer  
Allied Product  
Division

(A) OVERSIZE 5KV PORCELAIN BUSHING (B) STANDARD 5KV PORCELAIN BUSHING

FIGURE II RESULTS OF A 300 HOUR SALT RUN ON 5KV PORCELAIN BUSHINGS

Test Bushings (See Figures II and III)

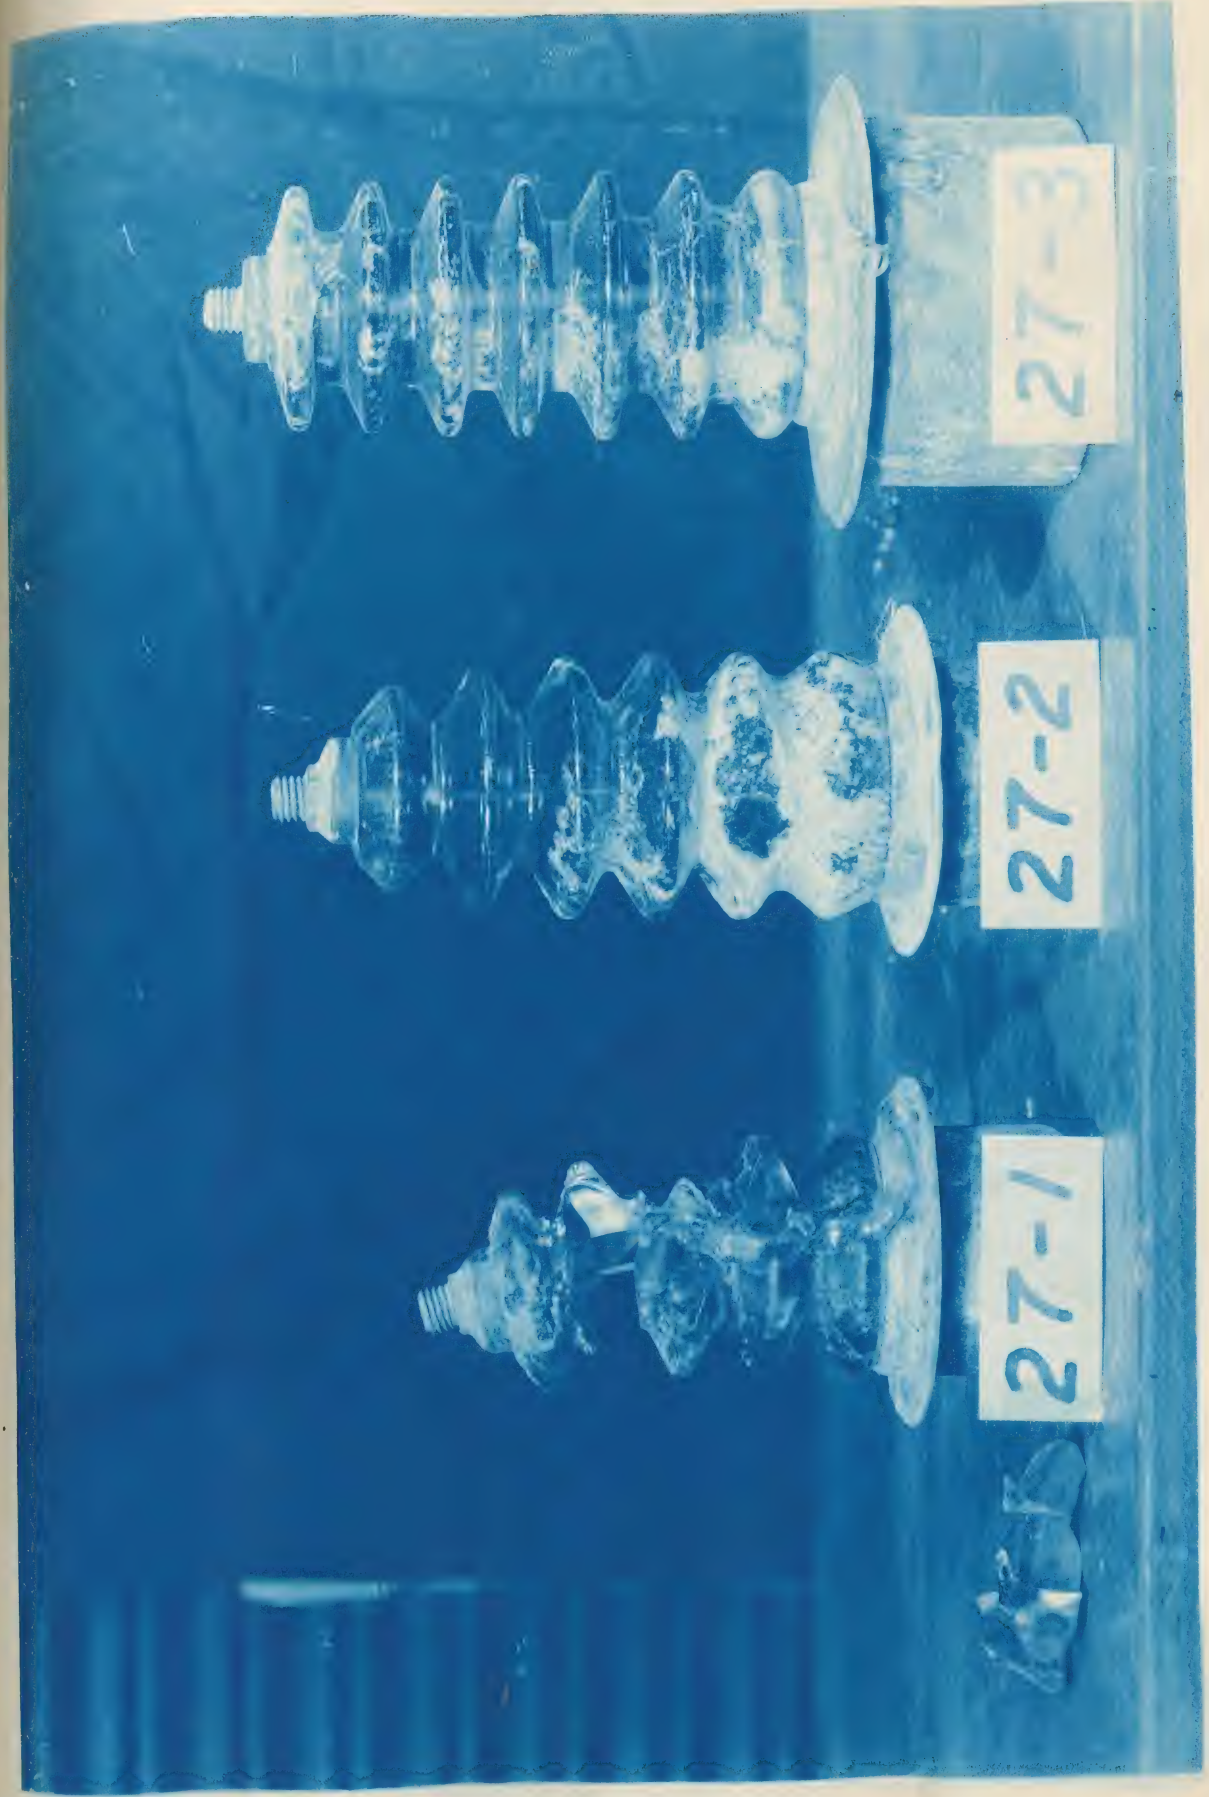
3017365

(A) 5KV - 14B4 (B) 8.7KV - 14B5 (C) 8.7KV - 14B25  
FIGURE III RESULTS OF A 300 HOUR SALT RUN ON 5KV G. E. GLASS BUSHINGS

2. The modified contour 14B25, 8.7 kv amber glass bushing had a total of 18% fewer leakage current surges above 10 ma. and also less surface deterioration than the 14B5, 8.7 kv G.E. amber glass bushing. Figures III and X.

The success of Kearney Airseal in eliminating the surface deterioration of the bushings is most apparent in a comparison of the photos of the protected and the unprotected bushings (Figs. III, VII and IX). The use of insulated cable and Airseal practically eliminated the current surges during the first 100 hours of the test runs and greatly reduced their number for the complete 350-hour run. It also appeared to minimize the effect of the arcing when it did occur. This may be because the Airseal, by increasing the resistance of the discharge path, reduces the magnitude of the current surges.

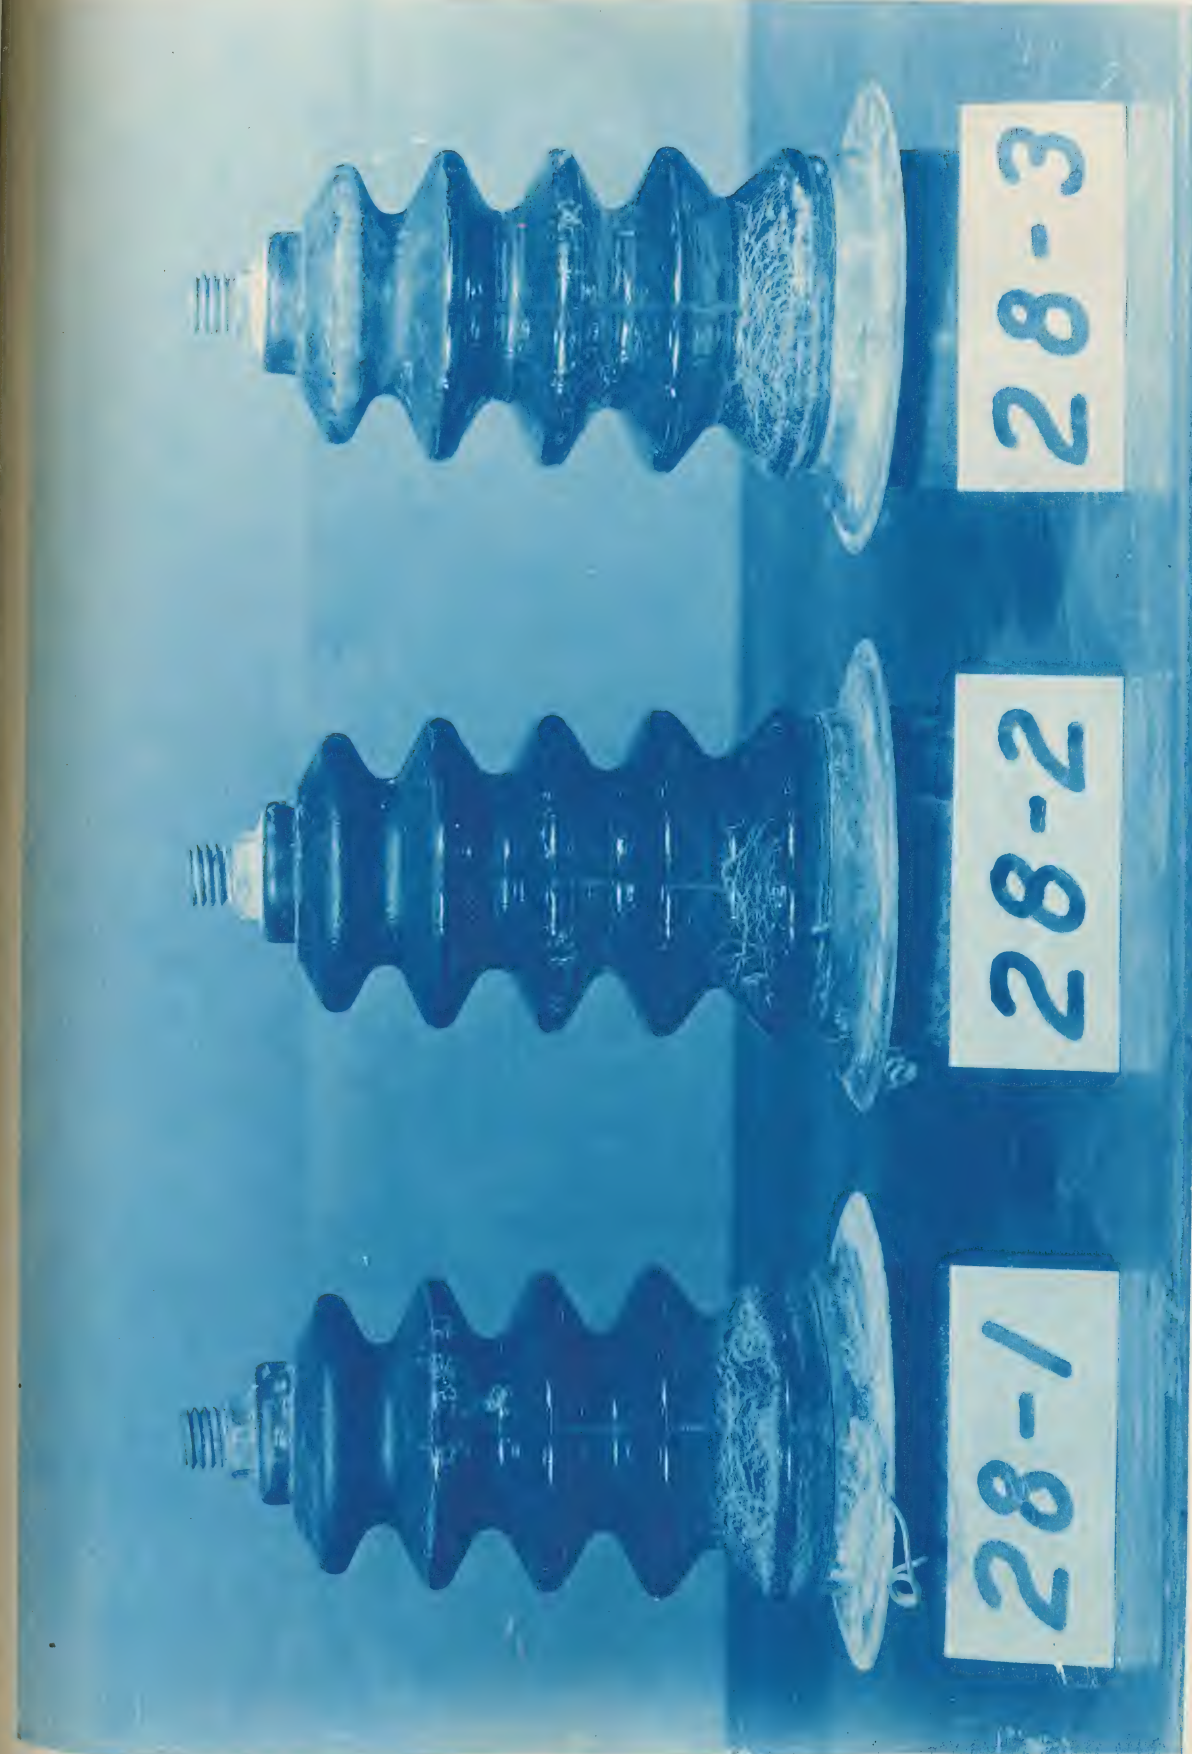
3017366

(A) 1.5 MEGOHM (B) 70 MEGOHM (C) 150 MEGOHM  
FIGURE IV RESULTS OF A 50 HOUR SALT RUN ON 5 KV G. E. GLASS BUSHINGS  
PARTIALLY COATED WITH RESCON

3. Semi-conducting Rescon surface coatings, partial and complete, have, so far, been unsuccessful in improving the performance of bushings operating in a salt-fog atmosphere. Figures IV, V, VI, XI, XII, and XIII.

Test Bushings (See Figure IV)

- (a) 5 Kv G.E. glass, 14B4, with Rescon coat over first 1-1/2 petticoats. Resistance - 1.5 megohms.
- (b) 5 Kv G.E. glass, 14B4, with Rescon coat over first 1-1/2 petticoats. Resistance - 70 megohms.
- (c) 5 Kv G.E. glass, 14B4.
- (d) 5 Kv G.E. glass, 14B4, with Rescon coat over first 1-1/2 petticoats. Resistance - 150 megohms.
- (e) 8.7 Kv G.E. glass, 14B25.

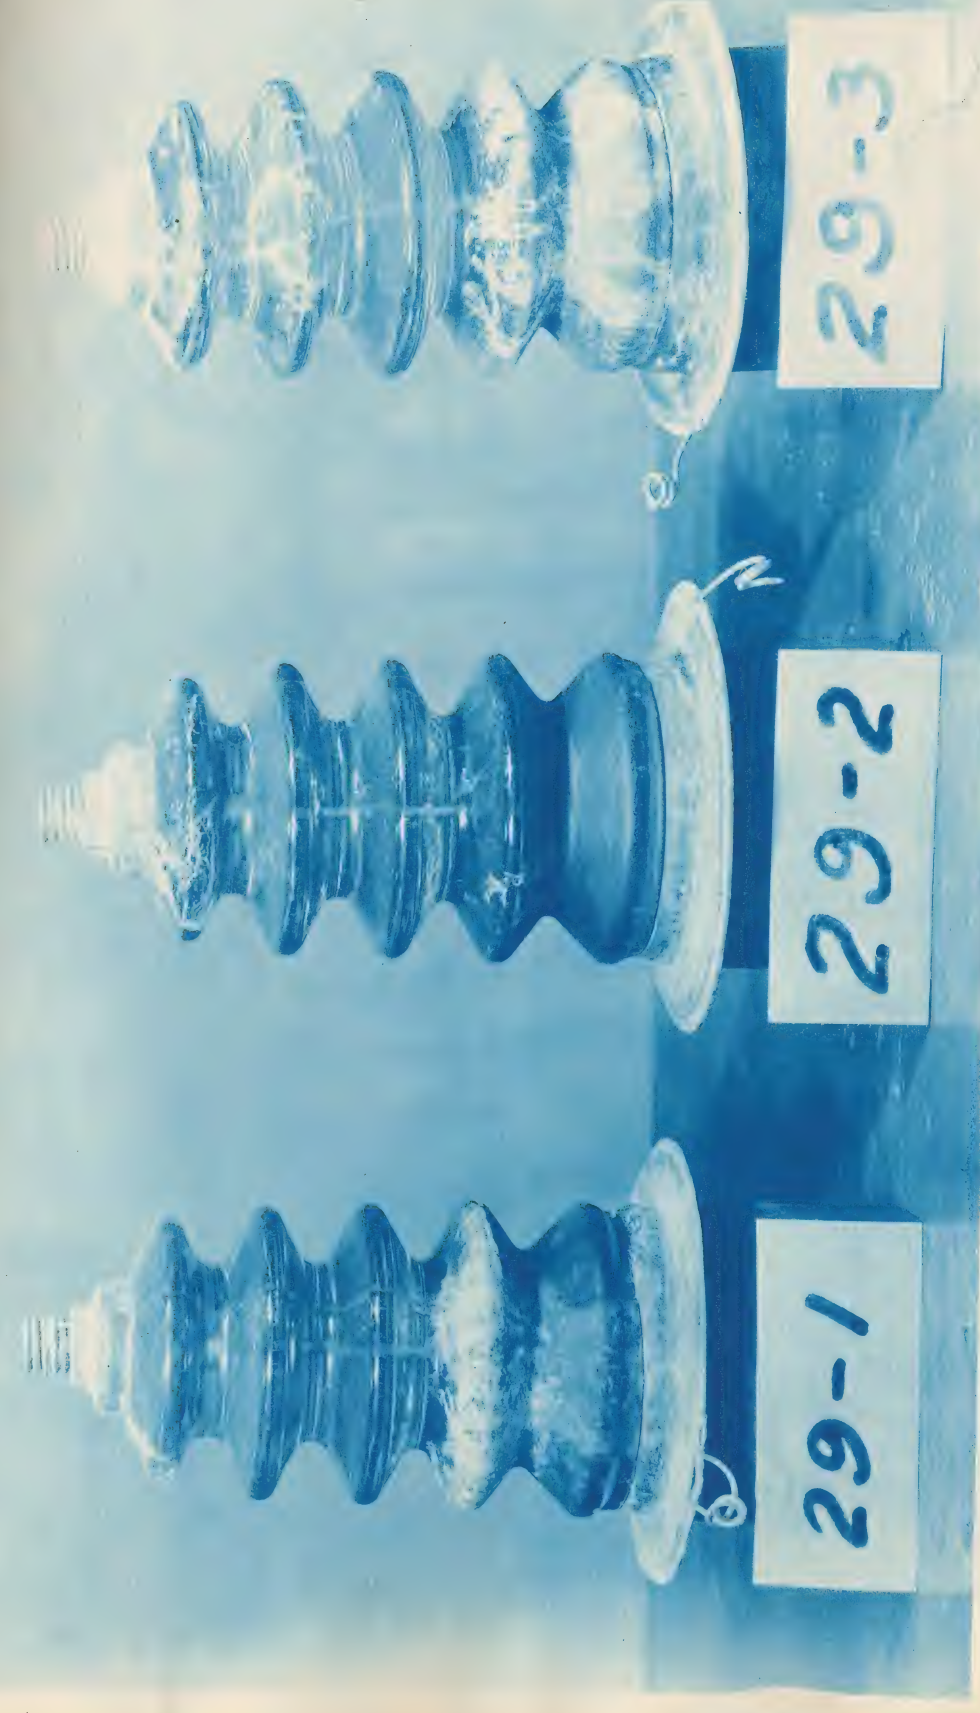
3017871  
Transformer  
and Allied Product  
Divisions

(A) 3 MEGOHM (B) 50 MEGOHM (C) 300 MEGOHM  
FIGURE V RESULTS OF A 100 HOUR SALT RUN ON 5 KV G. E. GLASS BUSHINGS  
PARTIALLY COATED WITH RESCON.

Test Bushings (See Figure V)

- (a) 5 Kv G.E. glass, 14B4, with Rescon coat over bottom 1-1/2 petticoats. Resistance - 3 megohms
- (b) 5 Kv G.E. glass, 14B4, with Rescon coat over bottom 1-1/2 petticoats. Resistance - 50 megohms
- (c) 5 Kv G.E. glass, 14B4.
- (d) 5 Kv G.E. glass, 14B4, with Rescon coat over bottom 1-1/2 petticoats. Resistance - 300 megohms

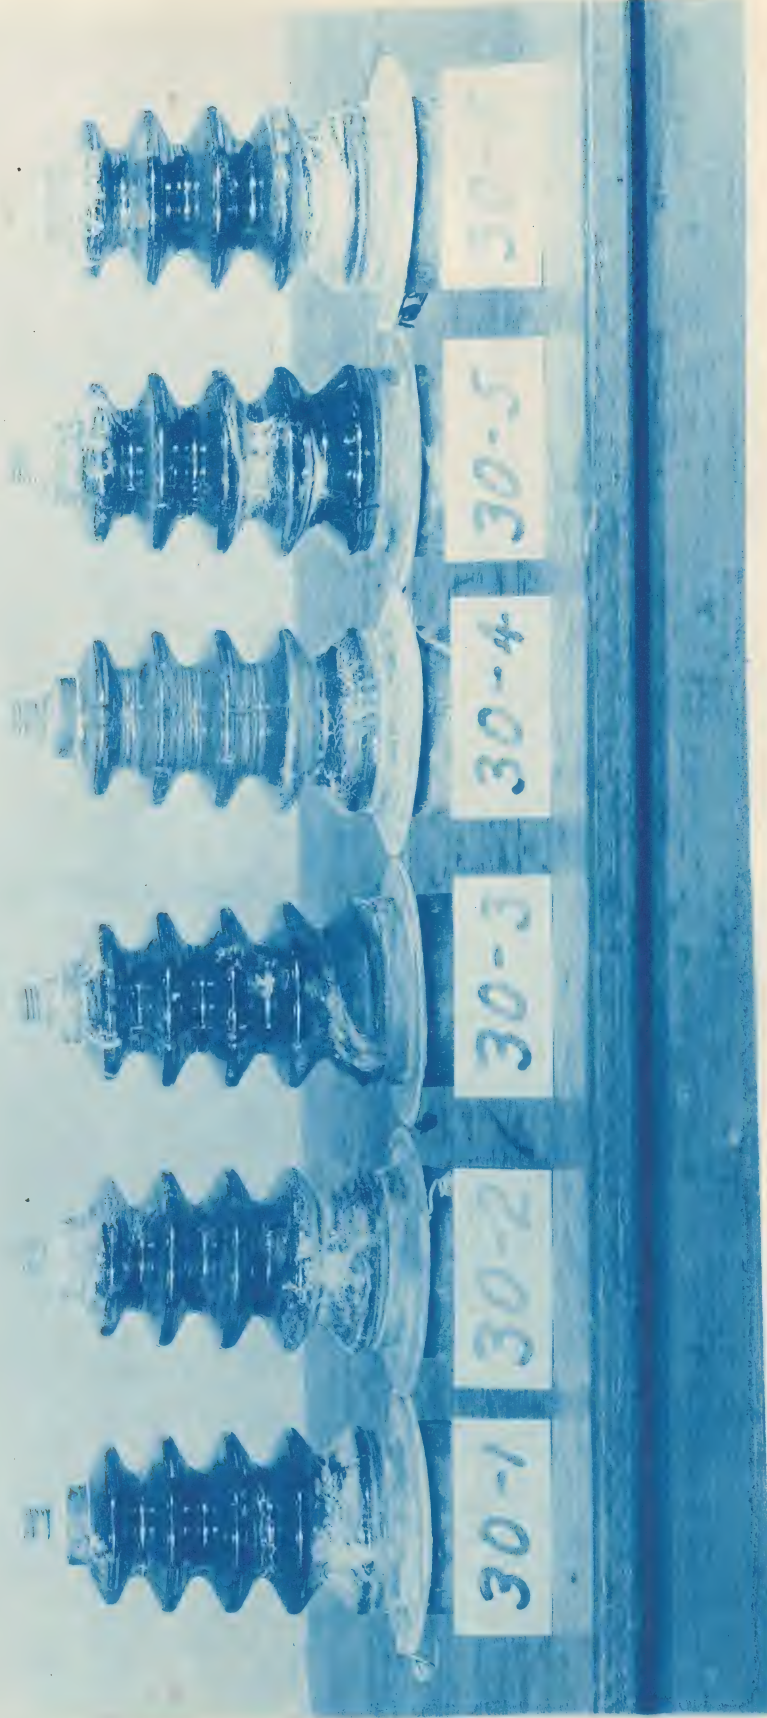
3018021

(A) 2760 MEGOHM (B) 9000 MEGOHM (C) 2860 MEGOHM (D) 0 MEGOHM  
(E) 42000 MEGOHM (F) 855 MEGOHM

FIGURE VI RESULTS OF A 100 HOUR SALT RUN ON 5KV G. E. GLASS BUSHINGS WITH INTERNAL RESCON COATING CONNECTING TOP TERMINAL TO GROUND FLANGE

Test Bushings (See Figure VI)

- (a) 5 Kv G.E. glass, 14B4, with internal Rescon coating from terminal to ground flange. Resistance - 2760 megohms.
- (b) 5 Kv G.E. glass, 14B4, with internal Rescon coating from terminal to ground flange. Resistance - 9000 megohms.
- (c) 5 Kv G.E. glass, 14B4, with internal Rescon coating from terminal to ground flange. Resistance - 2860 megohms.
- (d) 5 Kv G.E. glass, 14B4, no internal resistance.
- (e) 5 Kv G.E. glass, 14B4, with internal Rescon coating from terminal to ground flange. Resistance - 42,000 megohms.
- (f) 5 Kv G.E. glass, 14B4, with internal Rescon coating from terminal to ground flange. Resistance - 855 megohms.

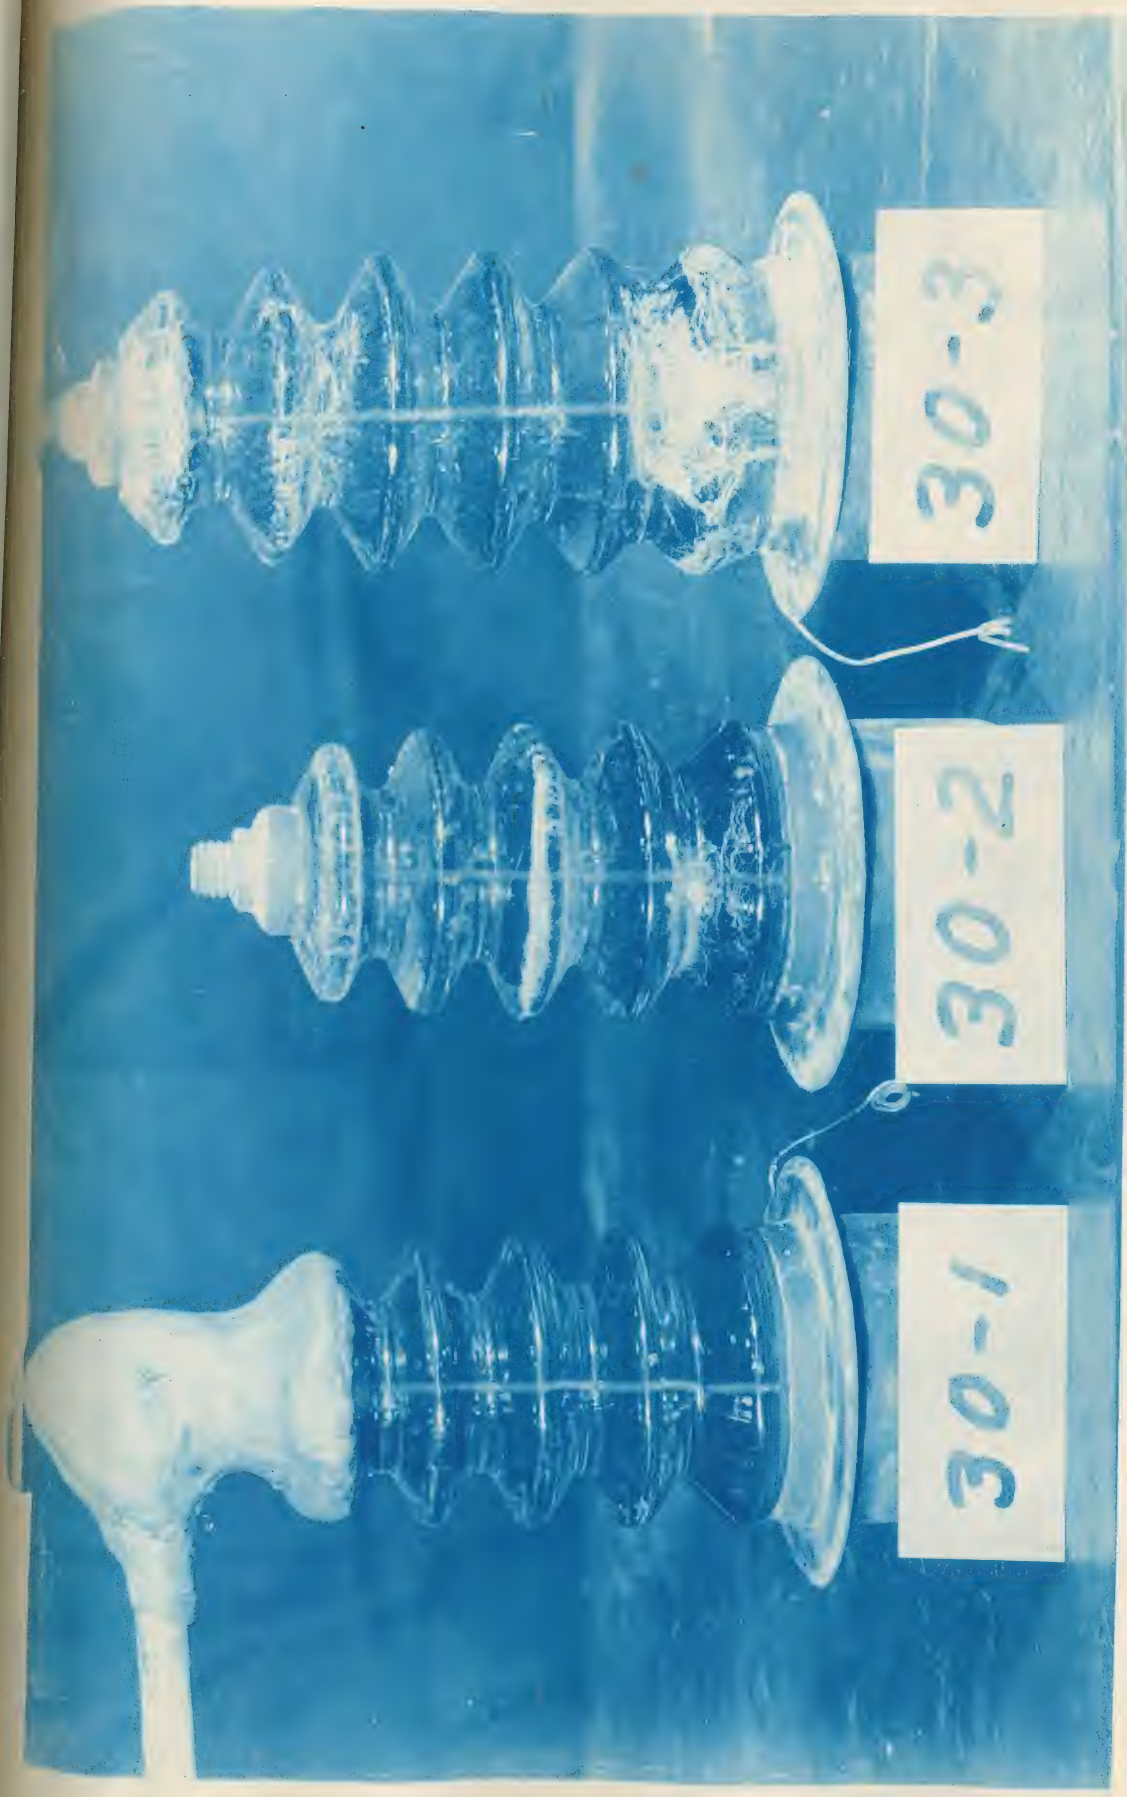
3018110  
Transformer  
and Allied Product  
Divisions

(A) 5 KV G. E., 14B4 WITH KEARNY AIRSEAL  
(B) 5 KV G. E., 14B4  
(C) 8.7 KV G. E., 14B5

FIGURE VII RESULTS OF A 100 HOUR SALT RUN ON G. E. GLASS BUSHING. ONE BUSHING HAVING TERMINAL AND CABLE JUNCTION SEALED WITH KEARNY AIRSEAL.

4. Salt deposition and surface deterioration have been greatly reduced on 14B4, 5 kv G.E. amber glass bushings that had the insulated moisture resistant cable and bushing terminal connection sealed against moisture by Kearney "Airseal". Figures VII, IX, XVI, and XVIII.

Test Bushings (See Figure VII)

- (a) 8.7 Kv G.E. glass, 14B25.
- (b) 5 Kv G.E. glass, 14B4, suspended from 2TW Rome Moisture Resistant Cable. Terminal and cable connection covered with Kearney Airseal.
- (c) 5 Kv G.E. glass, 14B4.

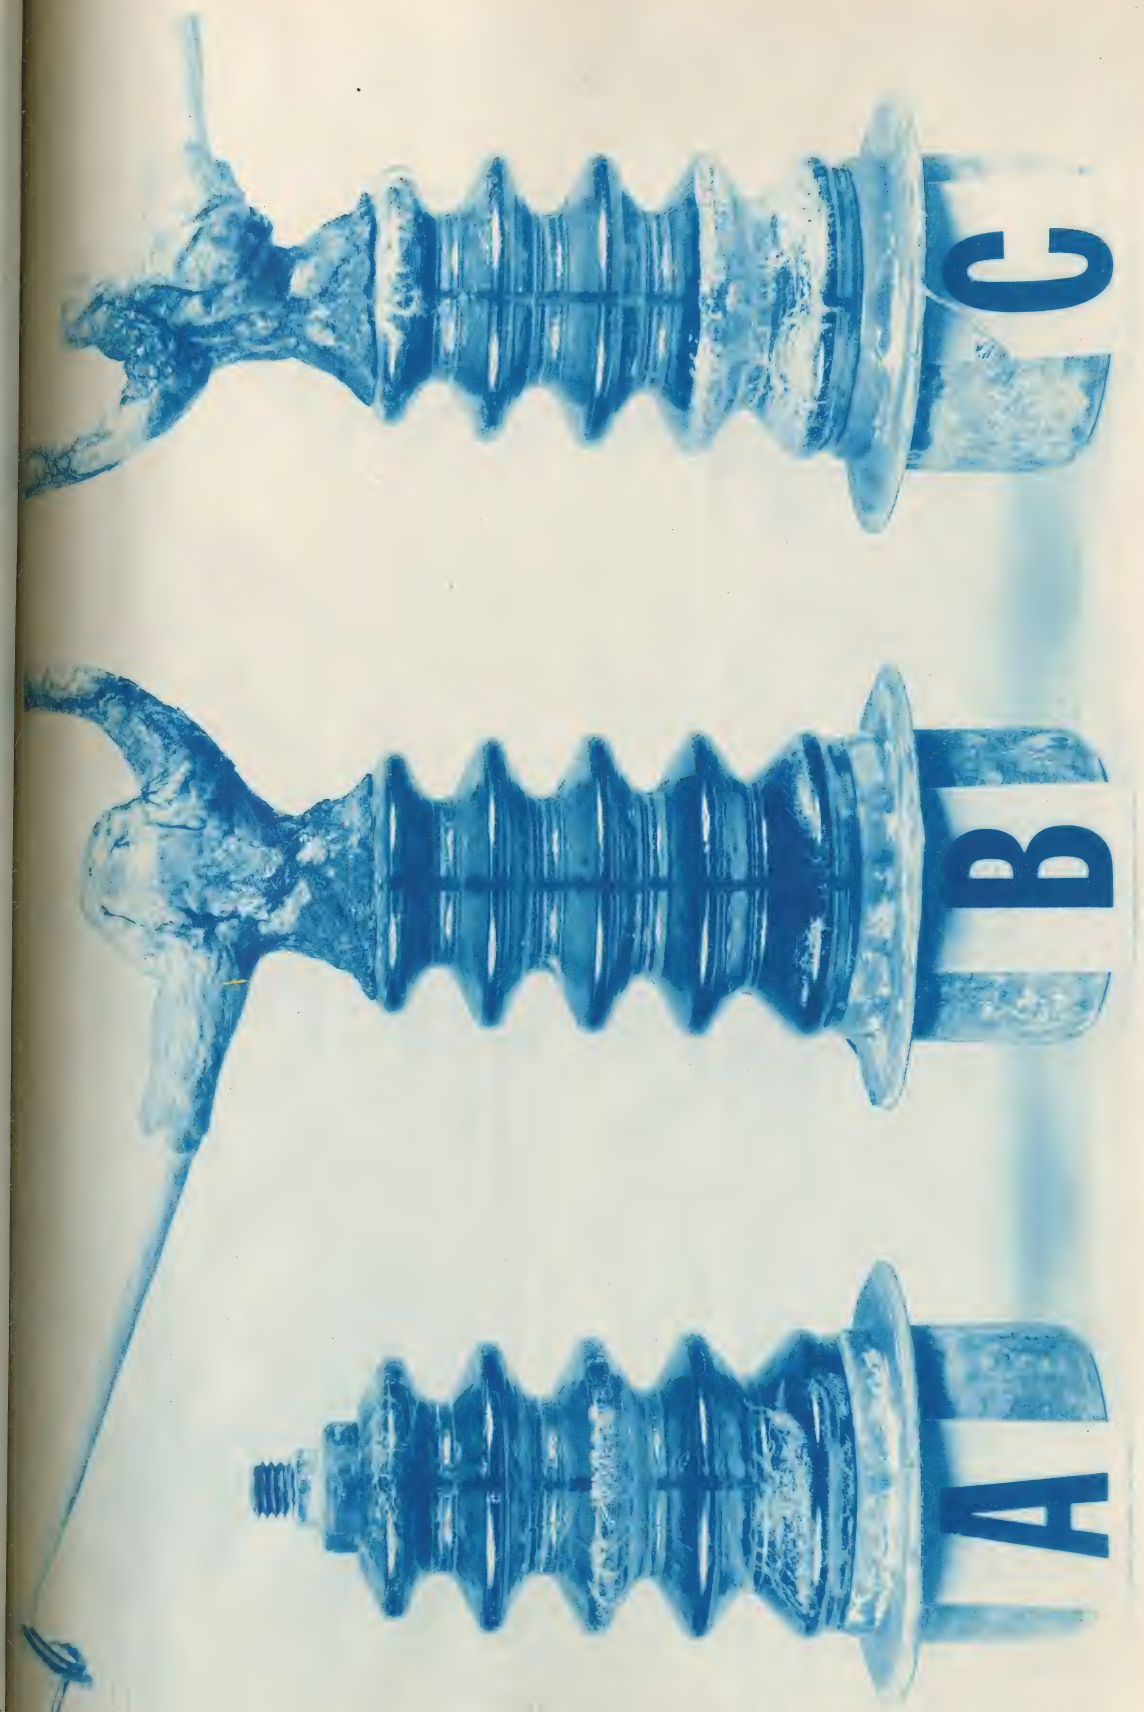
3019157

(A) BUSHING #1  
NO AIRSEAL PROTECTION

(B) BUSHING #2  
AIRSEAL OVER TERMINAL  
AND CONNECTION

(C) BUSHING #3  
AIRSEAL OVER TERMINAL  
AND CONNECTION

RESULTS OF A 120 HR. SALT-FOG TEST ON 5 KV G.E. GLASS BUSHINGS  
INSUFFICIENT KEARNEY "AIRSEAL" USED ON TERMINALS.

All bushings are 5 kv G.E. amber glass 14B4 bushings connected to voltage source with Rome 2TW Moisture Resistant Cable. (See Figure VIII).

- Bushing #1 - Terminal exposed.
- Bushing #2) - Terminals covered with one pad
- Bushing #3) - (1/8" x 3" x 4") of Kearney "Airseal".

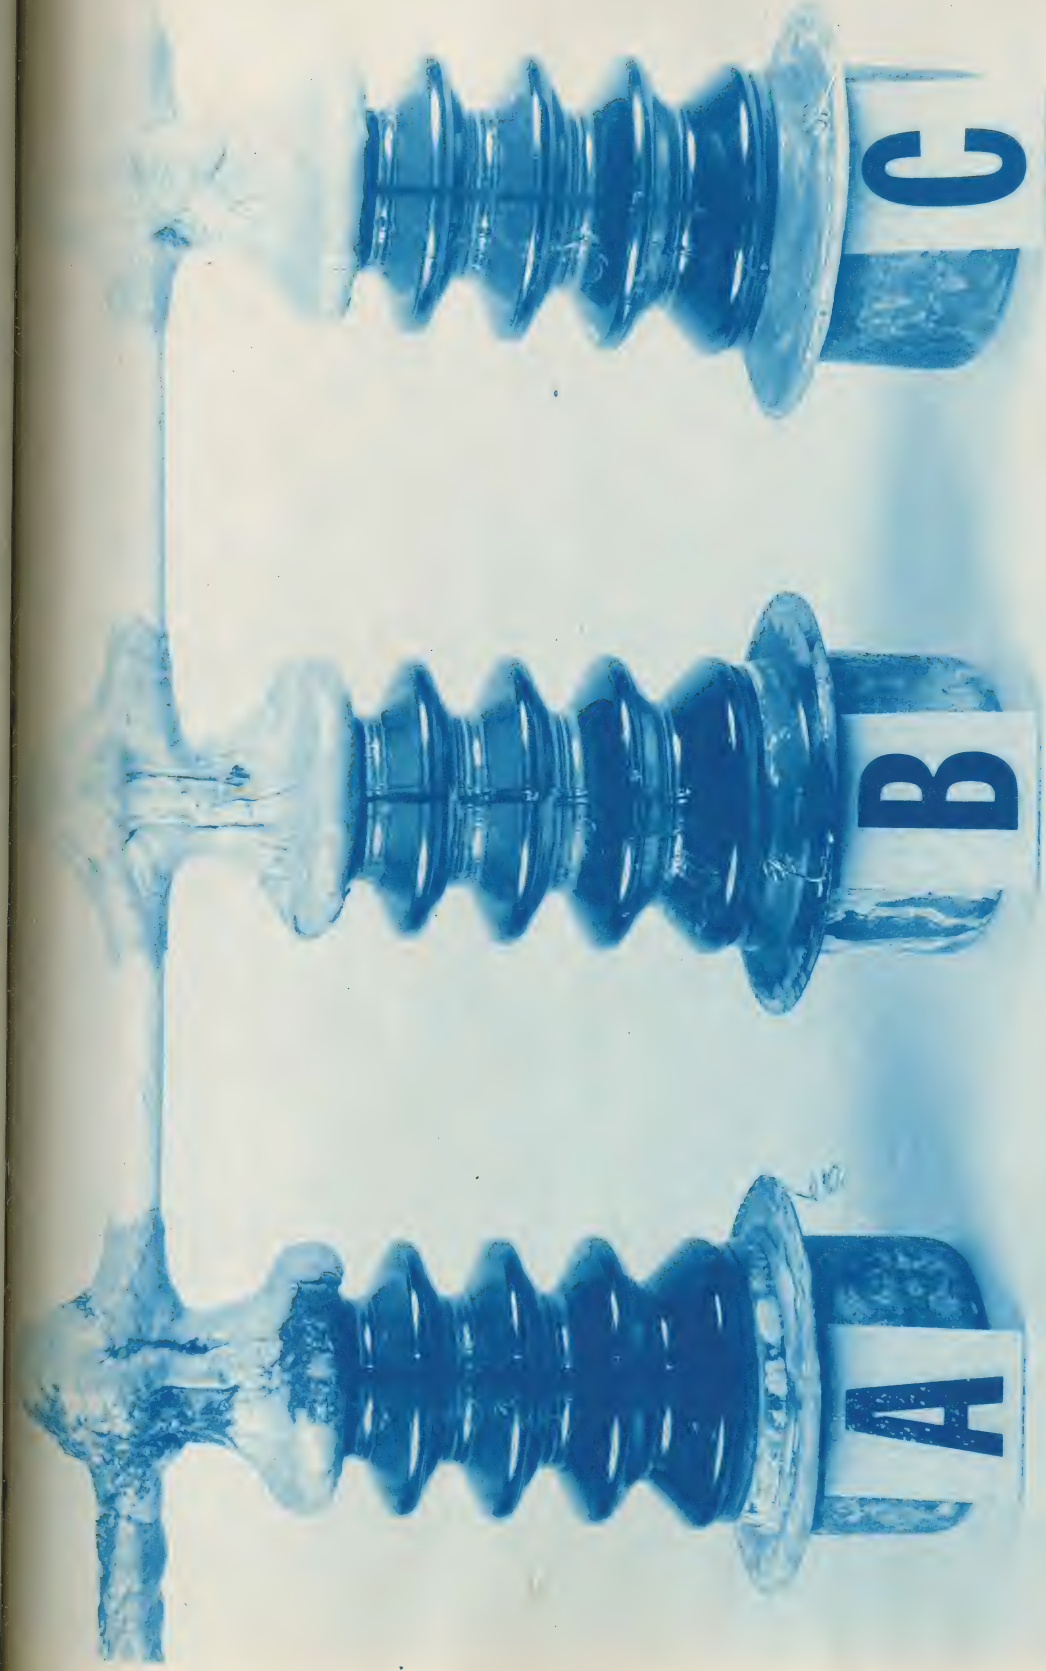
3019243

(A) BUSHING #1 (B) BUSHING #2 (C) BUSHING #3

FIGURE IX RESULTS OF A 359 HOUR SALT FOG TEST ON 5KV G.E. GLASS BUSHINGS - TERMINALS COVERED WITH TWO 1/8" x 3" x 4" PADS OF KEARNEY "AIRSEAL" AND CONNECTED TO VOLTAGE SOURCE WITH ROME 2TW MOISTURE RESISTANT CABLE.

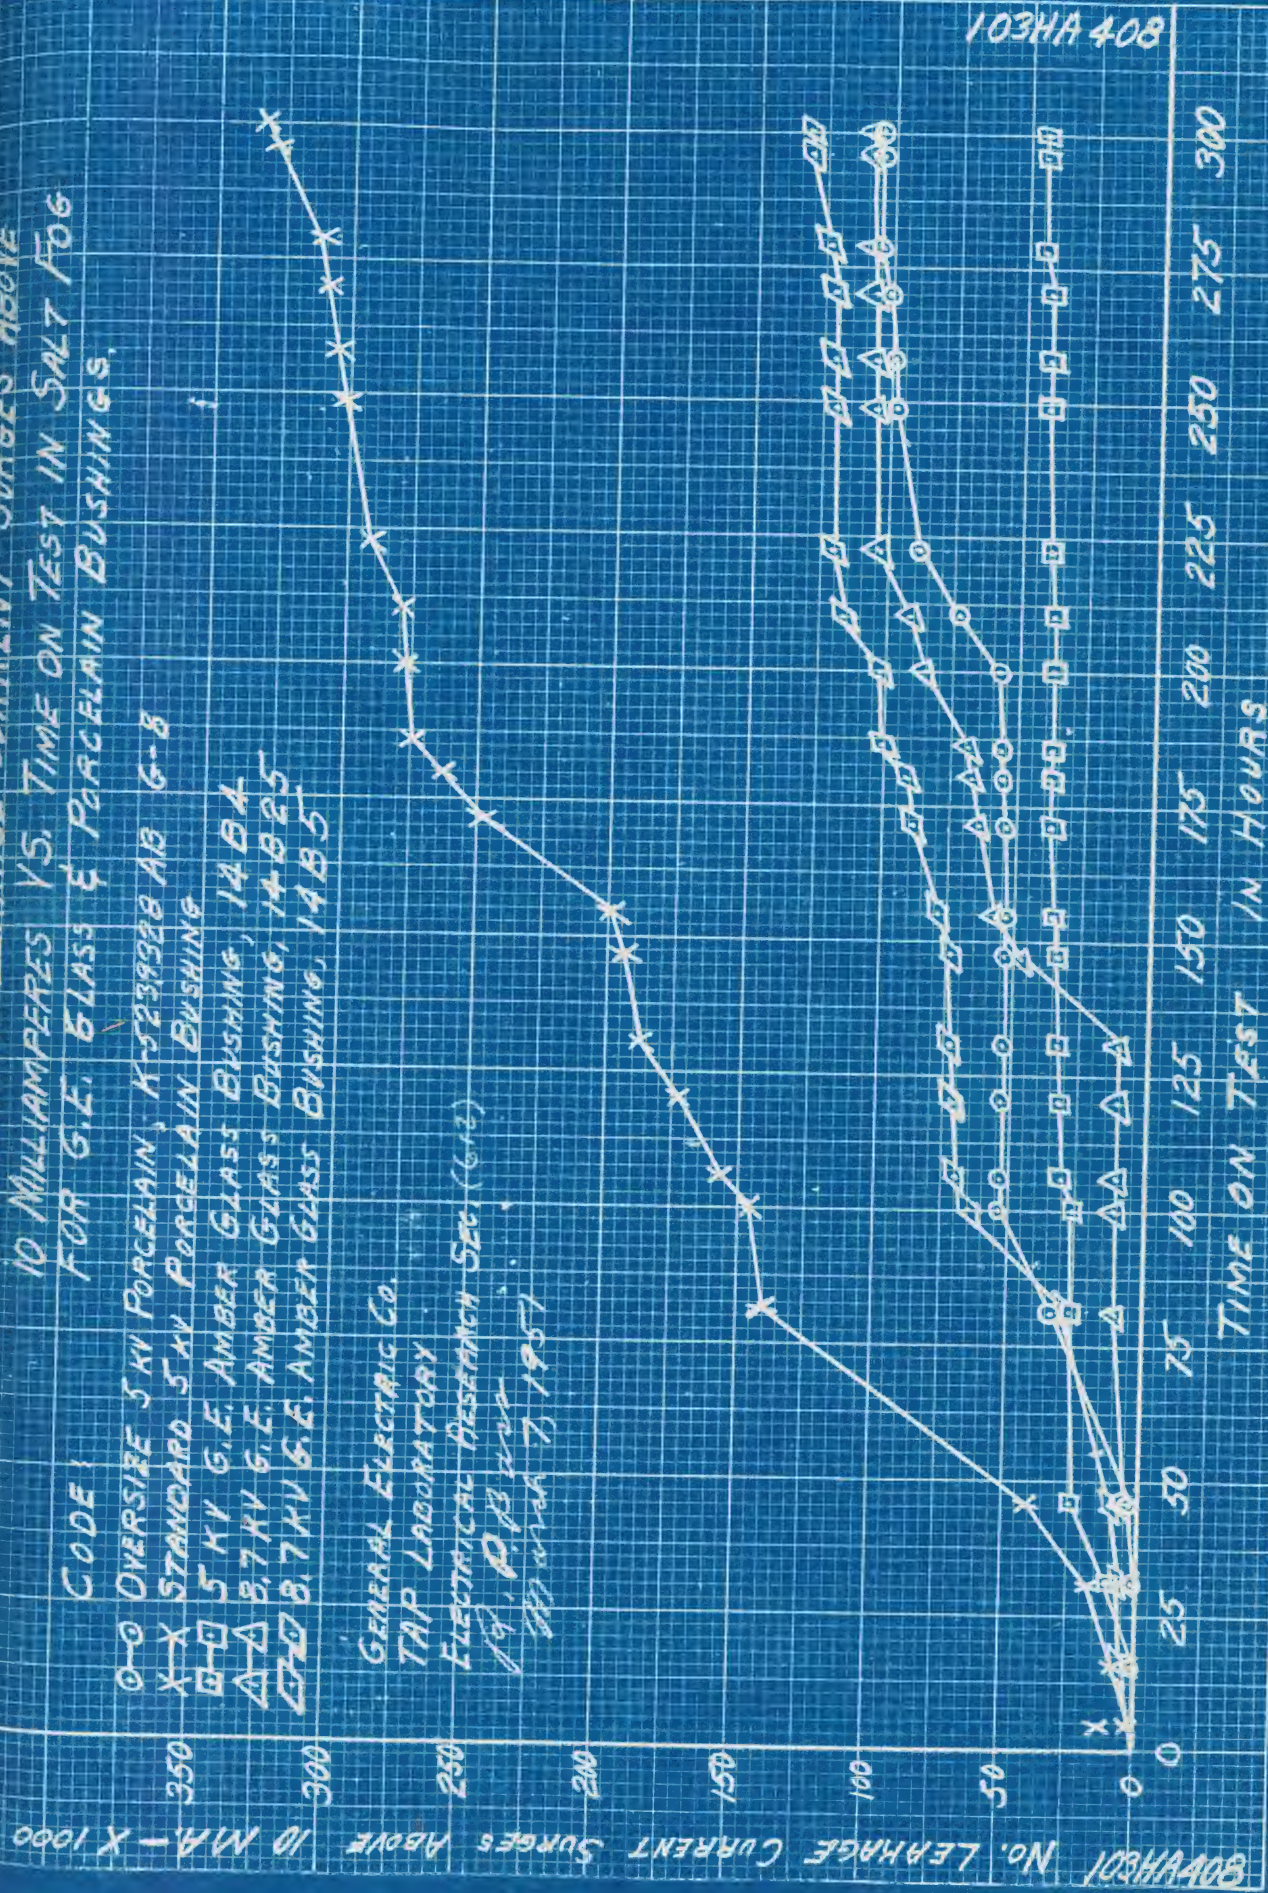
103HA 408  
7/13/57

FIGURE X NUMBER OF LEAKAGE CURRENT SURGES ABOVE 10 MILLIAMPERES VS. TIME ON TEST IN SALT FOG FOR G.I.E. GLASS & PORCELAIN BUSHINGS.

- O-O OVERSIZE 5 KV PORCELAIN, K-523928 AB G-8
- X-X STANDARD 5 KV PORCELAIN BUSHING
- 5 KV G.I.E. AMBER GLASS BUSHING, 14B4
- △-△ 8.7 KV G.I.E. AMBER GLASS BUSHING, 14B25
- ◇-◇ 8.7 KV G.I.E. AMBER GLASS BUSHING, 14B5
